## PROJECT PROFILE:

# WALL STABILIZATION

### THE RHODIA BUILDING

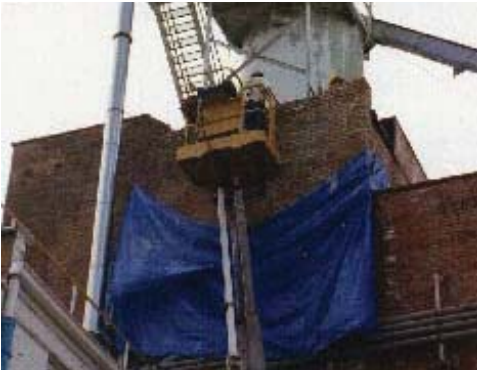
A 3 story brick building originally constructed in 1910 had many additions throughout the years. Over the last 10 plus years, there was a great deal of water penetration in the north building wall. The water penetration, combined with the expansive material being produced in the building, caused the wall on the 1st floor of the building to deteriorate to the point of becoming structurally unsound.

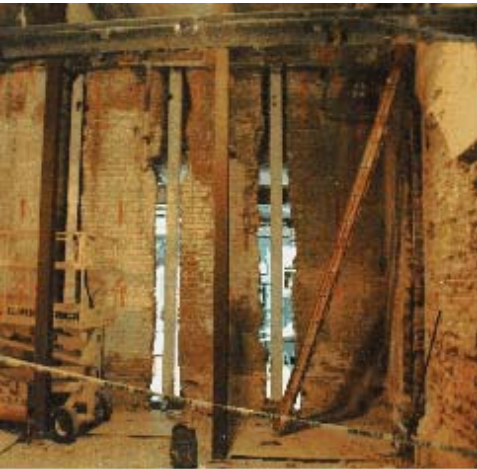
The job called for the wall at the 1st floor elevation to be replaced with 25 steel columns and then rebricked, while maintaining support for the two stories of wall above the first floor.

The work was done in phases by removing small narrow sections of wall spread across the wall and installing 6 columns in each phase. First, the strips of wall were demolished. Next, steel plates were installed at the column base and column head. Then, the steel columns were maneuvered into place and grouted. The wall stabilization was completed in a total of 4 phases and then bricked up.
